EXPERIMENTAL INVESTIGATION OF SLIDING ON COMPACT SLIDING SPECIMENS UNDER CYCLIC LOADS

Burkhard TROST¹, Harald SCHULER² and Bozidar STOJADINOVIC³

ABSTRACT

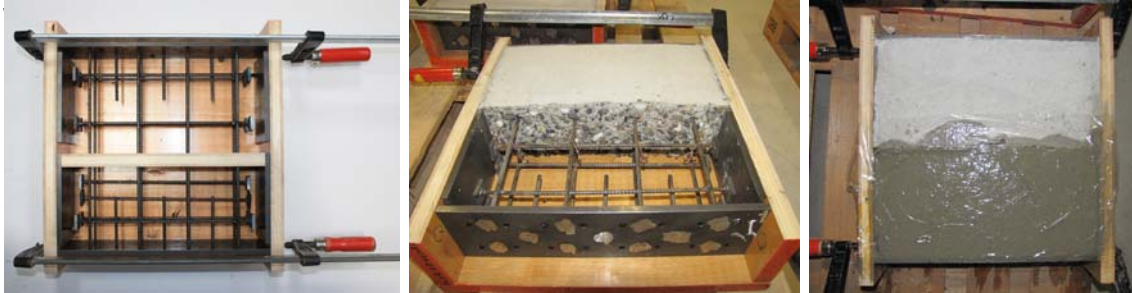
The vertical (y-direction) reinforcement is welded to the upper and the lower steel plates ($l/h/t=420/120/10$ mm), as shown in Figure 2. The horizontal (x-direction) reinforcement is anchored using small steel head plates $l/h/t=25/30/6$ mm. Additionally, 110 mm long reinforcement bars that do not reach the cold joint are welded on the upper and lower steel plate to strengthen the connection between the concrete and the steel plates to prevent the occurrence of large cracks between the steel plates and the concrete. Horizontal load transfer steel plates ($l/h/t=180/120/10$ mm) are connected to the concrete of the specimen using small screws ($2 \times M6$). The average tensile strength of the reinforcement is 615 N/mm^2 .

Figure 3: Compact specimen construction

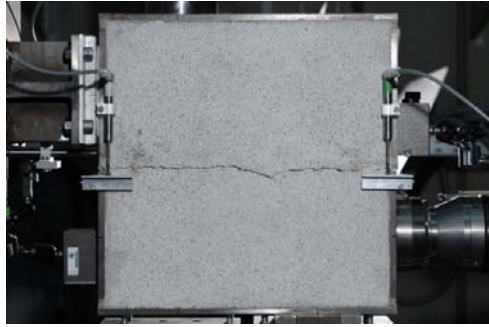
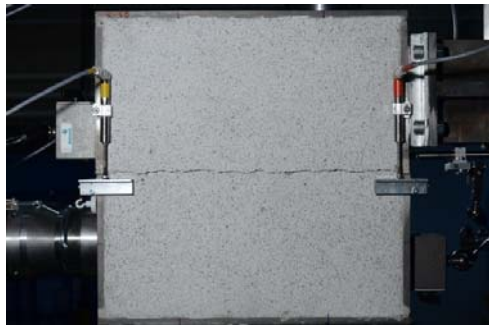
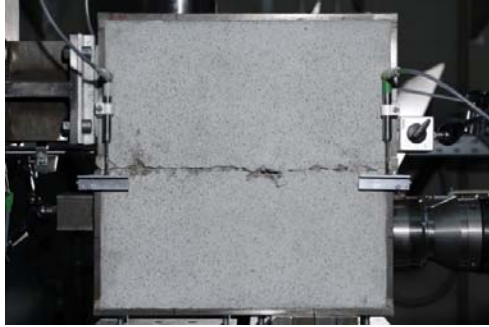
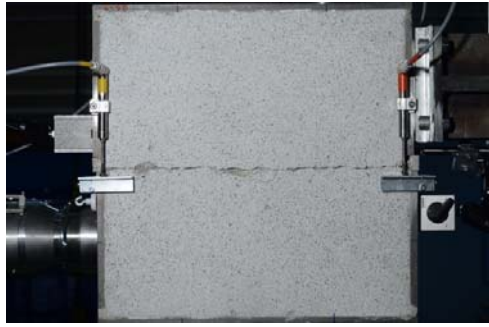
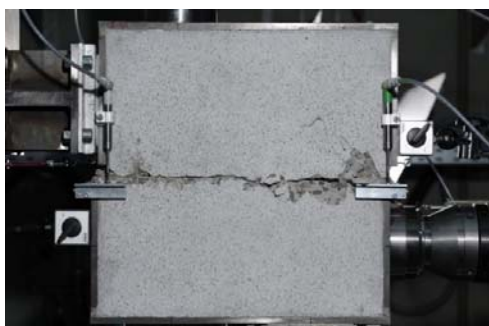
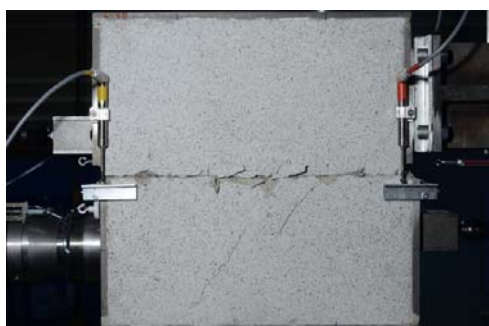
Table 3. Pictures of Specimen PK4

Pictures of Specimen PK4 are shown in Table 3. Surface A and Surface B are describing the front and the back side of the specimen. The pictures were taken at the maximum horizontal displacement of the 1st 2 mm, 5 mm and 10 mm half cycles. Almost no damage was visible after the first 2 mm half cycles. Small cracks and local spalling of the concrete cover were observable at the maximum amplitude of the 1st 5 mm half cycle. Major diagonal cracking and damage occurred during the 10 mm half cycle. Damage to the horizontal crack surface started to develop after the peak shear was reached.

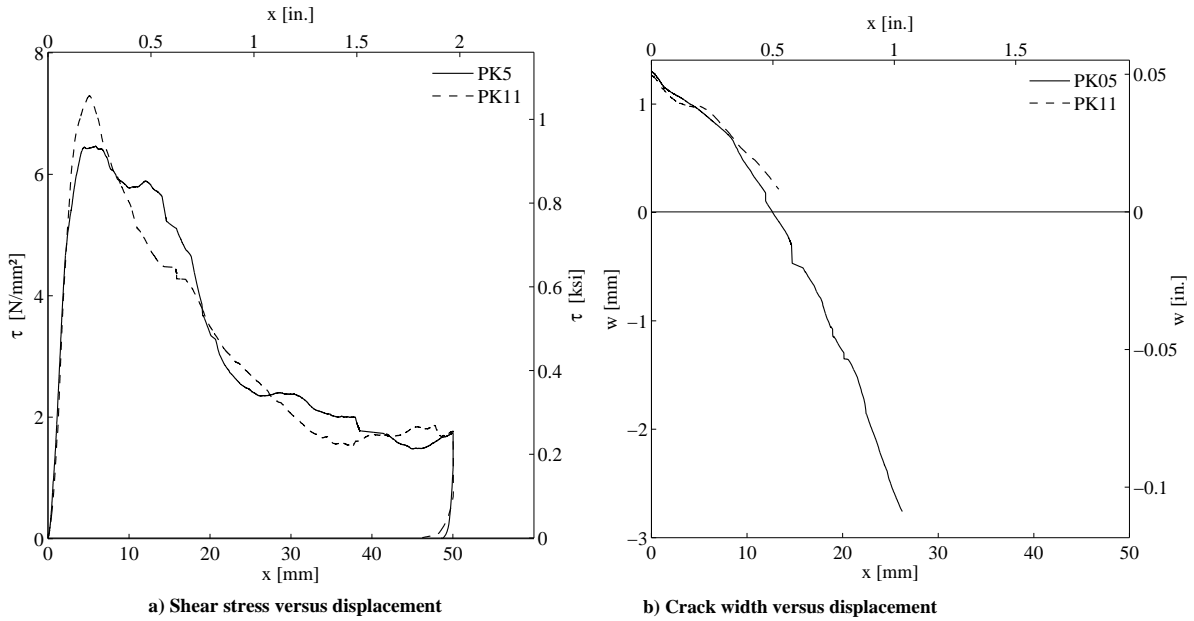
Specimens PK05 and PK11 are the same as Specimens PK02, PK03 and PK04, the only difference being that after being pre-cracked to 2 mm, they were monotonically loaded to failure due to diagonal compression. The response plots are shown in Figure 7. The average peak shear stress of 6.9 N/mm² was reached at an average horizontal displacement of 5.5 mm. The tests were stopped at a displacement of 50 mm. The measurement of the crack width stopped earlier because the anchorage of the LVDT's was destroyed by the spalling concrete cover. The LVDT measurements of crack width were discontinued at 26 mm of displacement because the instrument anchor points were damaged and became loose.

Figure 7: Response of Specimens PK05 and PK11

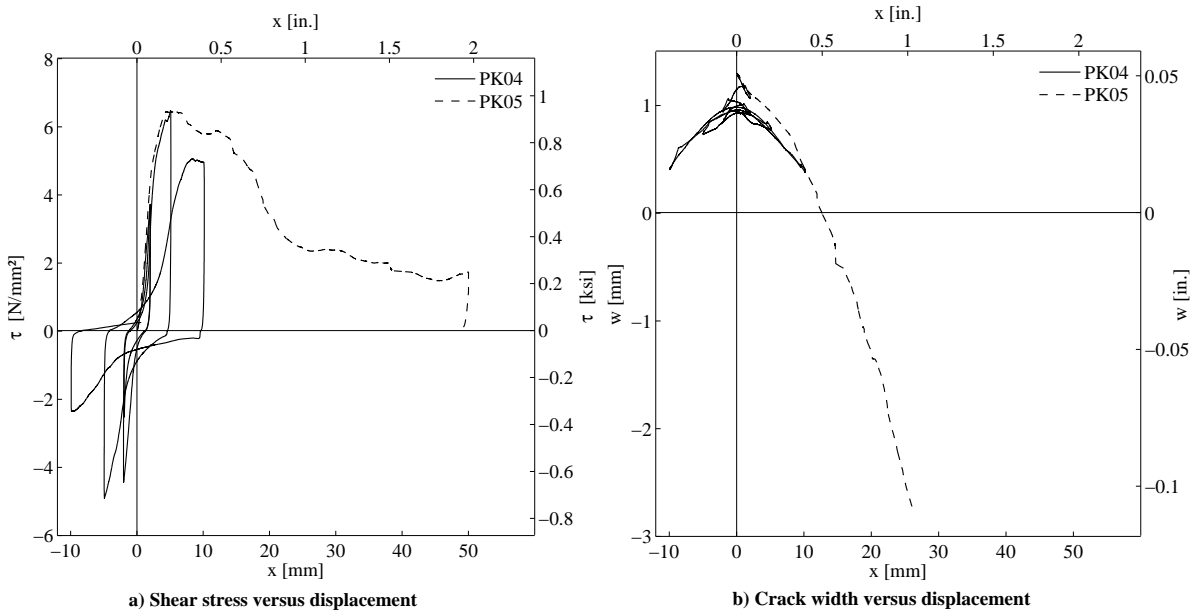
The obtained monotonic shear stress horizontal deformation response plots envelope the cyclic response plot, as shown in Figure 8 which compares the responses of Specimens PK04 and PK05. The cyclically loaded specimens attain the same strength as the monotonically loaded ones in the first half cycle to a new displacement magnitude. This applies in the post-peak response range, where the specimens soften, if the new displacement amplitude is substantially larger than the amplitude of the previous displacement cycle. When the cyclic specimens reach the monotonic response envelope, their response follows that of the monotonically tested specimens.

Figure 8: Response of Specimens PK04 and PK05

1. The load-deformation response plots obtained from the monotonic tests envelope the load-deformation responses of the cyclically tested specimens, both before the peak strength is attained (in the stiffening response range) and in the post-peak (softening) response range.

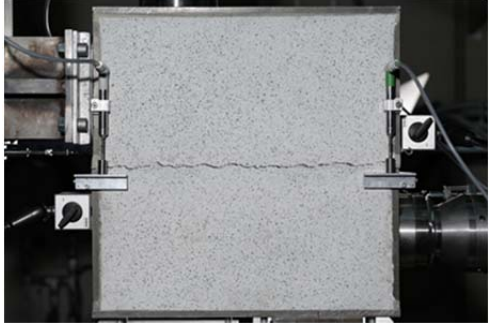
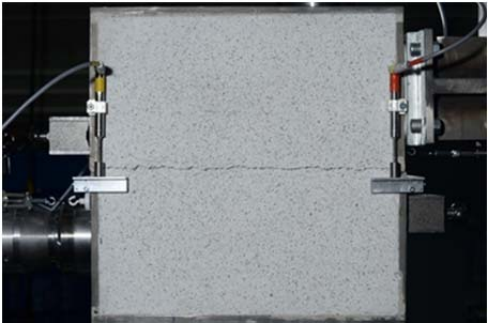
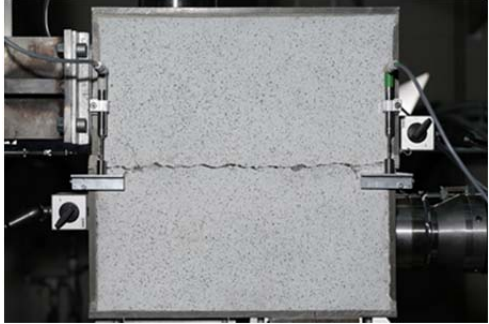
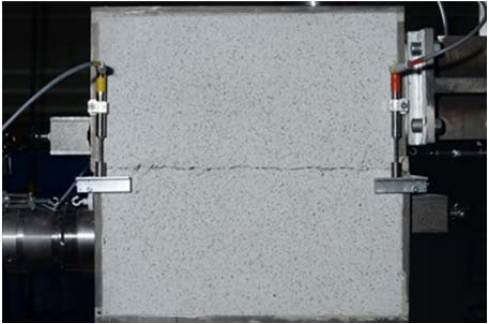
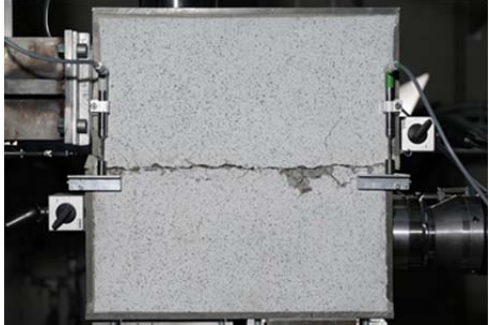
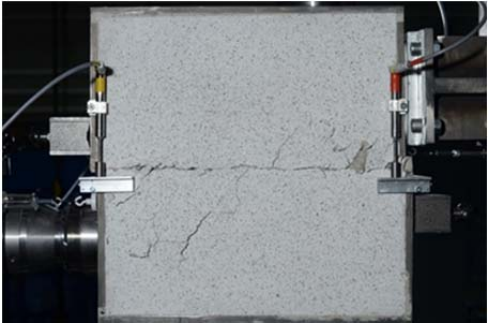
Table 4. Pictures of Specimen PK11

Table 4 shows the photos taken at different displacement stages during the test with Specimen PK11. The visible damage on the surface is similar to that observed during the cyclic Specimen PK04 test. Almost no damage is visible at the horizontal displacement of 2 mm. At 5mm, small cracks are visible. At 10 mm, major diagonal cracks are developing and the concrete cover close to the cold joint starts to spall. At 20 mm, the concrete cover has spalled in the direct surrounding area, although large cracks developing in a wide area of the specimen and large parts of the concrete cover are starting to spall. At 50 mm, major parts of the concrete cover have spalled and the vertically bent reinforcement bars are visible.
