Barriers against invasive crayfish species in natural waters and fish passes - Practical experience

Raphael Krieg, Alex King, Armin Zenker*

University of Applied Sciences and Arts Northwestern Switzerland, School of Life Sciences, Institute for Ecopreneurship, Hofackerstrasse 30, 4132, Muttensz, Switzerland

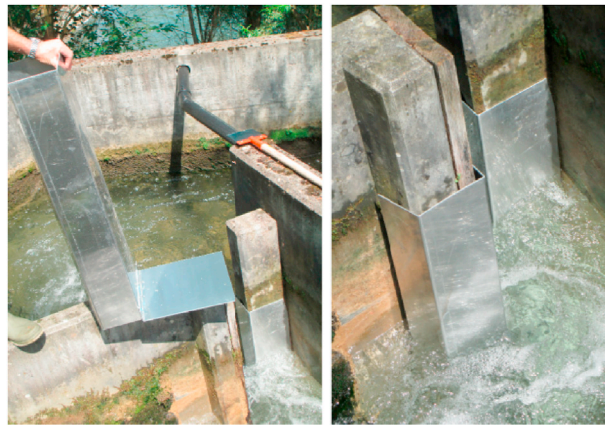
Fig. 2. Vertical-slot fish-pass with aluminium coating on the sections between the two pools.

In a fish ladder, aluminium was used to coat the sidewalls and the bottom of the passage between the two pools of a vertical-slot fish-pass to create smooth surface which aimed to prevent upstream movement of signal crayfish (Fig. 2). The velocity in barrier passage was slowed from 1.7 to 0.6–0.7 m/s by damming the downstream pool of the fish-pass using a formwork panel.

Forty signal crayfish were marked with holes in their telson using punch pliers and placed in the pool directly downstream of the barrier. Four baited traps were placed in the pools up- and downstream of the fish-pass to observe the movement of marked crayfish. Caught, marked crayfish were released again in the pool downstream of the barrier. Caught, unmarked signal crayfish were removed from the river. Crayfish were in the experimental set-up for 57 days and traps were emptied a total of 33 times. After removing the formwork panel at the end of the crayfish experiment, the fish trap at the upstream exit of the fish-pass was monitored for two weeks to see if the barrier hindered fish migration with a water velocity of 1.7 m/s.

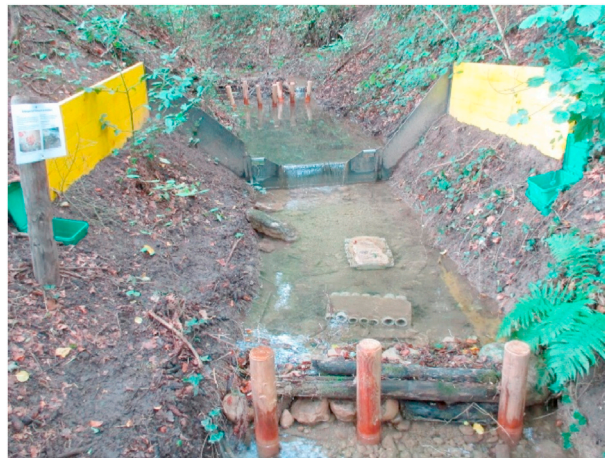
Fig. 5. Barrier with driftwood retention structure upstream and small dam further downstream.

The barrier was constructed in a 1.5 m wide, steep banked forest brook, which was inhabited by signal crayfish. During the first of two trials, the barrier design included a 30 cm high vertical iron plate which was extended on both banks for an additional metre. 1.5 m long sheets of wood were placed downstream of the barrier parallel with each bank to guide crayfish back into the water (later referred to as “land barrier”) (Fig. 5). Plastic buckets were buried in the ground at the downstream end of both land barriers to catch crayfish walking overland. A small dam was constructed 3.5 m downstream of the barrier to create a slow flowing 30 cm pool of water to prevent marked crayfish moving directly downstream. Artificial refuges were placed in the pool to minimize the urge to migrate downstream. Wooden stakes (later referred to as “driftwood retention structure”) were put into the waterbed 5 m upstream of the barrier to stop branches being caught in the barrier, which would aid crayfish movement over the barrier.

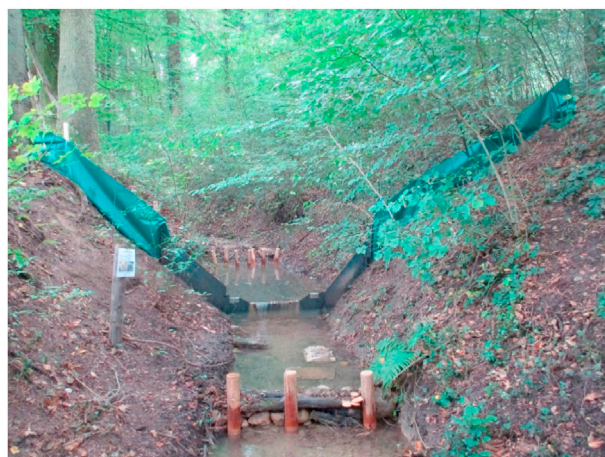
Fig. 6. Barrier including an extended land barrier on both banks.

Crayfish which had fallen into a bucket were released again downstream directly in front of the barrier. After 21 days, the land barrier was lengthened 4.5 m up the bank, using plastic foil which is used for frog fences, to determine how far signal crayfish migrate on land (Fig. 6). Again, a bucket was buried on each bank to catch crayfish moving along the extended land barrier.

After the barrier at Winterthur was extended along the banks and directly connected to the water, no further overland movement by crayfish could be observed. As predicted, the extension of the barrier led crayfish downwards into the water and not onto land. For this reason, a barrier should be placed directly on the water line to prevent overland movement and with it stop crayfish from overcoming the obstacle.

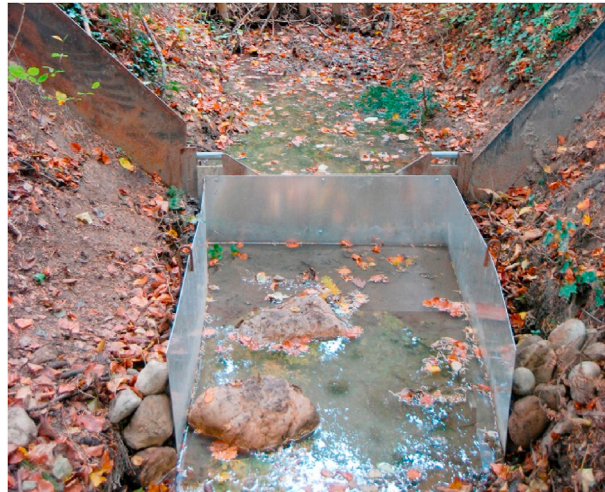
Fig. 7. Modified barrier with aluminium plates on both banks.

In order to further prevent overland movement of crayfish the barrier was modified by installing a 40 cm high, 1.5 m long aluminium plate in the waterbody directly downstream of the barrier on either bank (Fig. 7). A GoProHero3+ camera was installed which took a picture every 5 s to document the behaviour of crayfish downstream of the barrier. Glow sticks of different colours and sizes were glued in various combinations on the carapace of 60 signal crayfish for identification. Marked crayfish were released at night and behaviours including land movement and passing of barrier were observed for 3 h. After 1.5 h, crayfish which were found 30 m downstream of the barrier were collected and released again in the pool directly in front of the barrier.

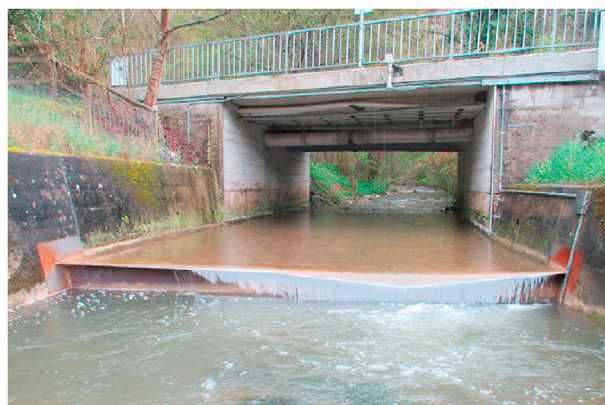
Fig. 8. Crayfish barrier with overhanging lip in the *Etzgerbach*.

A PIT-Tag antenna system was used to record the up- and downstream movement of crayfish and brown trout. The pass-over-antennas were placed 9 m upstream and 60 m downstream of the barrier to detect when the barrier was passed as well as any downstream movement. In September, after barrier construction, 112 brown trout and 102 bullheads were placed 80 m downstream of the barrier and 107 crayfish were put in the pool directly downstream the barrier.

Throughout the duration of one year, the antennas recorded when crayfish and fish passed over them. The site was visited once a week during the experimental period to download data, check antenna functionality and ensure barrier maintenance. The barrier cost CHF 10'000 to build including machines, workers and materials.

In contrast to stainless steel, the steel barrier in the *Etzgerbach* began to rust very quickly, which meant construction parts were rougher consequently making it easier to grip to overcome the barrier. It can be assumed that if the surface of the walls are sufficiently rough, crayfish would also overcome the obstacle by climbing these. This could not be observed in any of these studies.

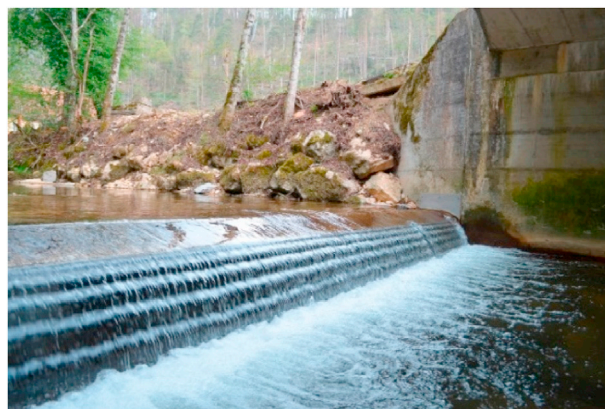
Fig. 9. Crayfish barrier in the Lützel with aluminium plates attached on to the pillars of the bridge.

To prevent signal crayfish from migrating from the main river into the Lützel a crayfish barrier was constructed. It consisted of an aluminium plate with a 30 cm overhanging lip which was screwed to a steel H-beam to create a free fall. (Fig. 9). The aluminium plate had a slight downstream facing angle to make it easier for trout to jump upstream. The H-beam was set on large blocks of natural stone which acted as a foundation. The barrier was placed directly upstream of the bridge so that the pillars of the bridge could be used as pre-existing barriers to prevent overland movement. On both bridge pillars, aluminium plates were screwed on to prevent crayfish from overcoming the barrier by climbing up rough surfaces.

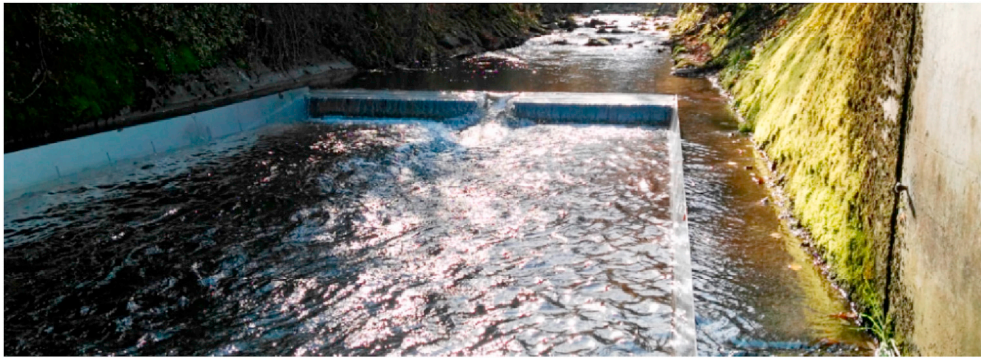
Fig. 10. Crayfish barrier in the *Pfaffnern* with a high-flow mid-section which is passable by fish.

In contrast to the previous examples of barrier models in natural waters which were not passable by weak-swimming fish, this barrier was built directly on the river bed and without a free fall so as to allow weak-swimming fish to pass (Fig. 10). The barrier was placed on the upstream section of a long passage. The barrier consisted of a 30 cm high concrete bar which stood on the bottom of the brook. A stainless-steel plate created a 20 cm overhanging lip angled downstream. On each side of the river there was a concrete path which allowed mammals, amphibians and reptiles to walk alongside the water. As this was a possible pathway for crayfish, an additional steel plate was laterally attached to prevent crayfish from climbing onto it and walking around the barrier. The barrier creates a slow-moving pool upstream which leads into the two concrete paths as well as being released at high velocity through a gap at the centre of the barrier. The high velocity at the centre is to stop crayfish but allow fish to pass. A Bluetooth camera in front of the barrier allowed real-time monitoring of the site via smartphone to detect whether the barrier had been made passable by driftwood or stones.
